Geotechnical Review

**Consideration of Ground Conditions and Subsidence Hazard
to Old Stocks Court, Upper Basildon, Berkshire**

Doc Ref: GRR001/Rev02

Date: September 2015

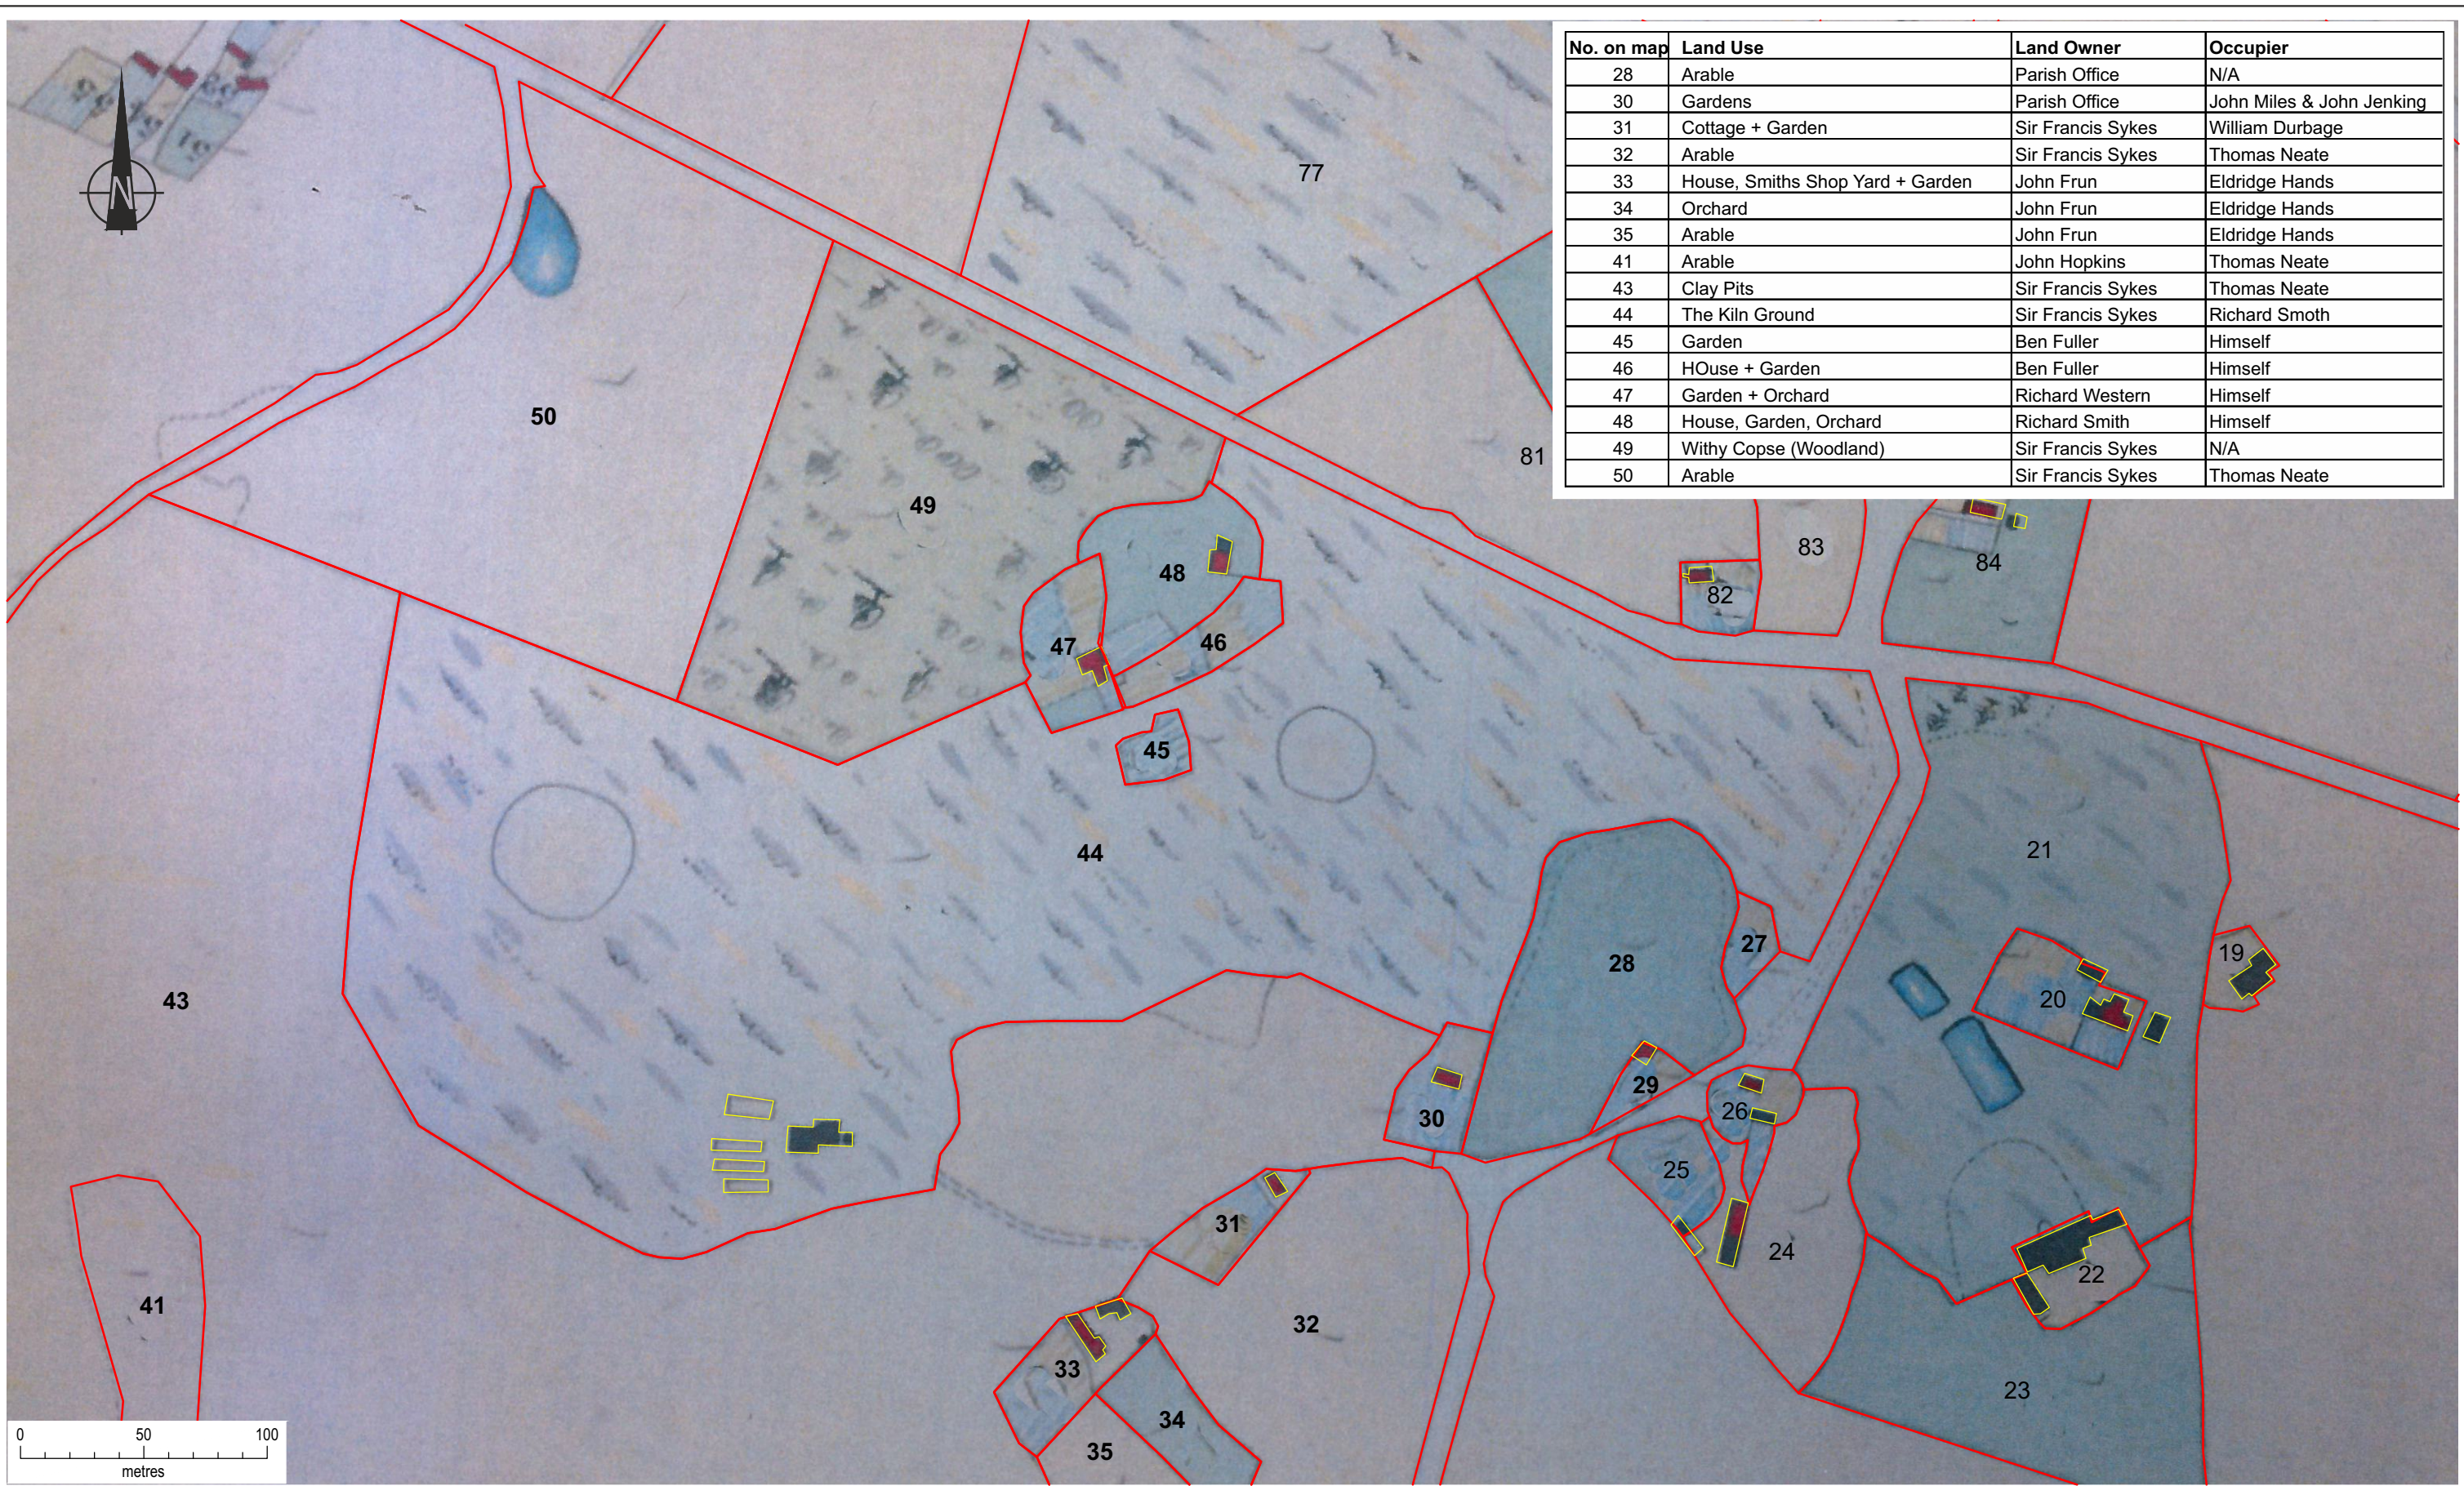
FIGURE 2

- 4.2.3 The next historical map is the Tithe Map dating from 1839 (see Figure 2). This shows some useful details of the area of interest. The Basildon Brick Works was active at this time (Land Plot 44: The Kiln Ground), the land being worked by Richard Smith and used for brick making. It is interesting to note that the position of the kiln and four probable drying sheds (hacks) are shown towards the southern edge of the land plot at this time. Another plot (Land Plot 43: Clay Pits) wraps around the south side of The Kiln Ground. Richard Smith appears to own and live on “Plot 48: House, Garden, Orchard” to the north east of the brick works, adjacent to Wither Copse (Land Plot 49).

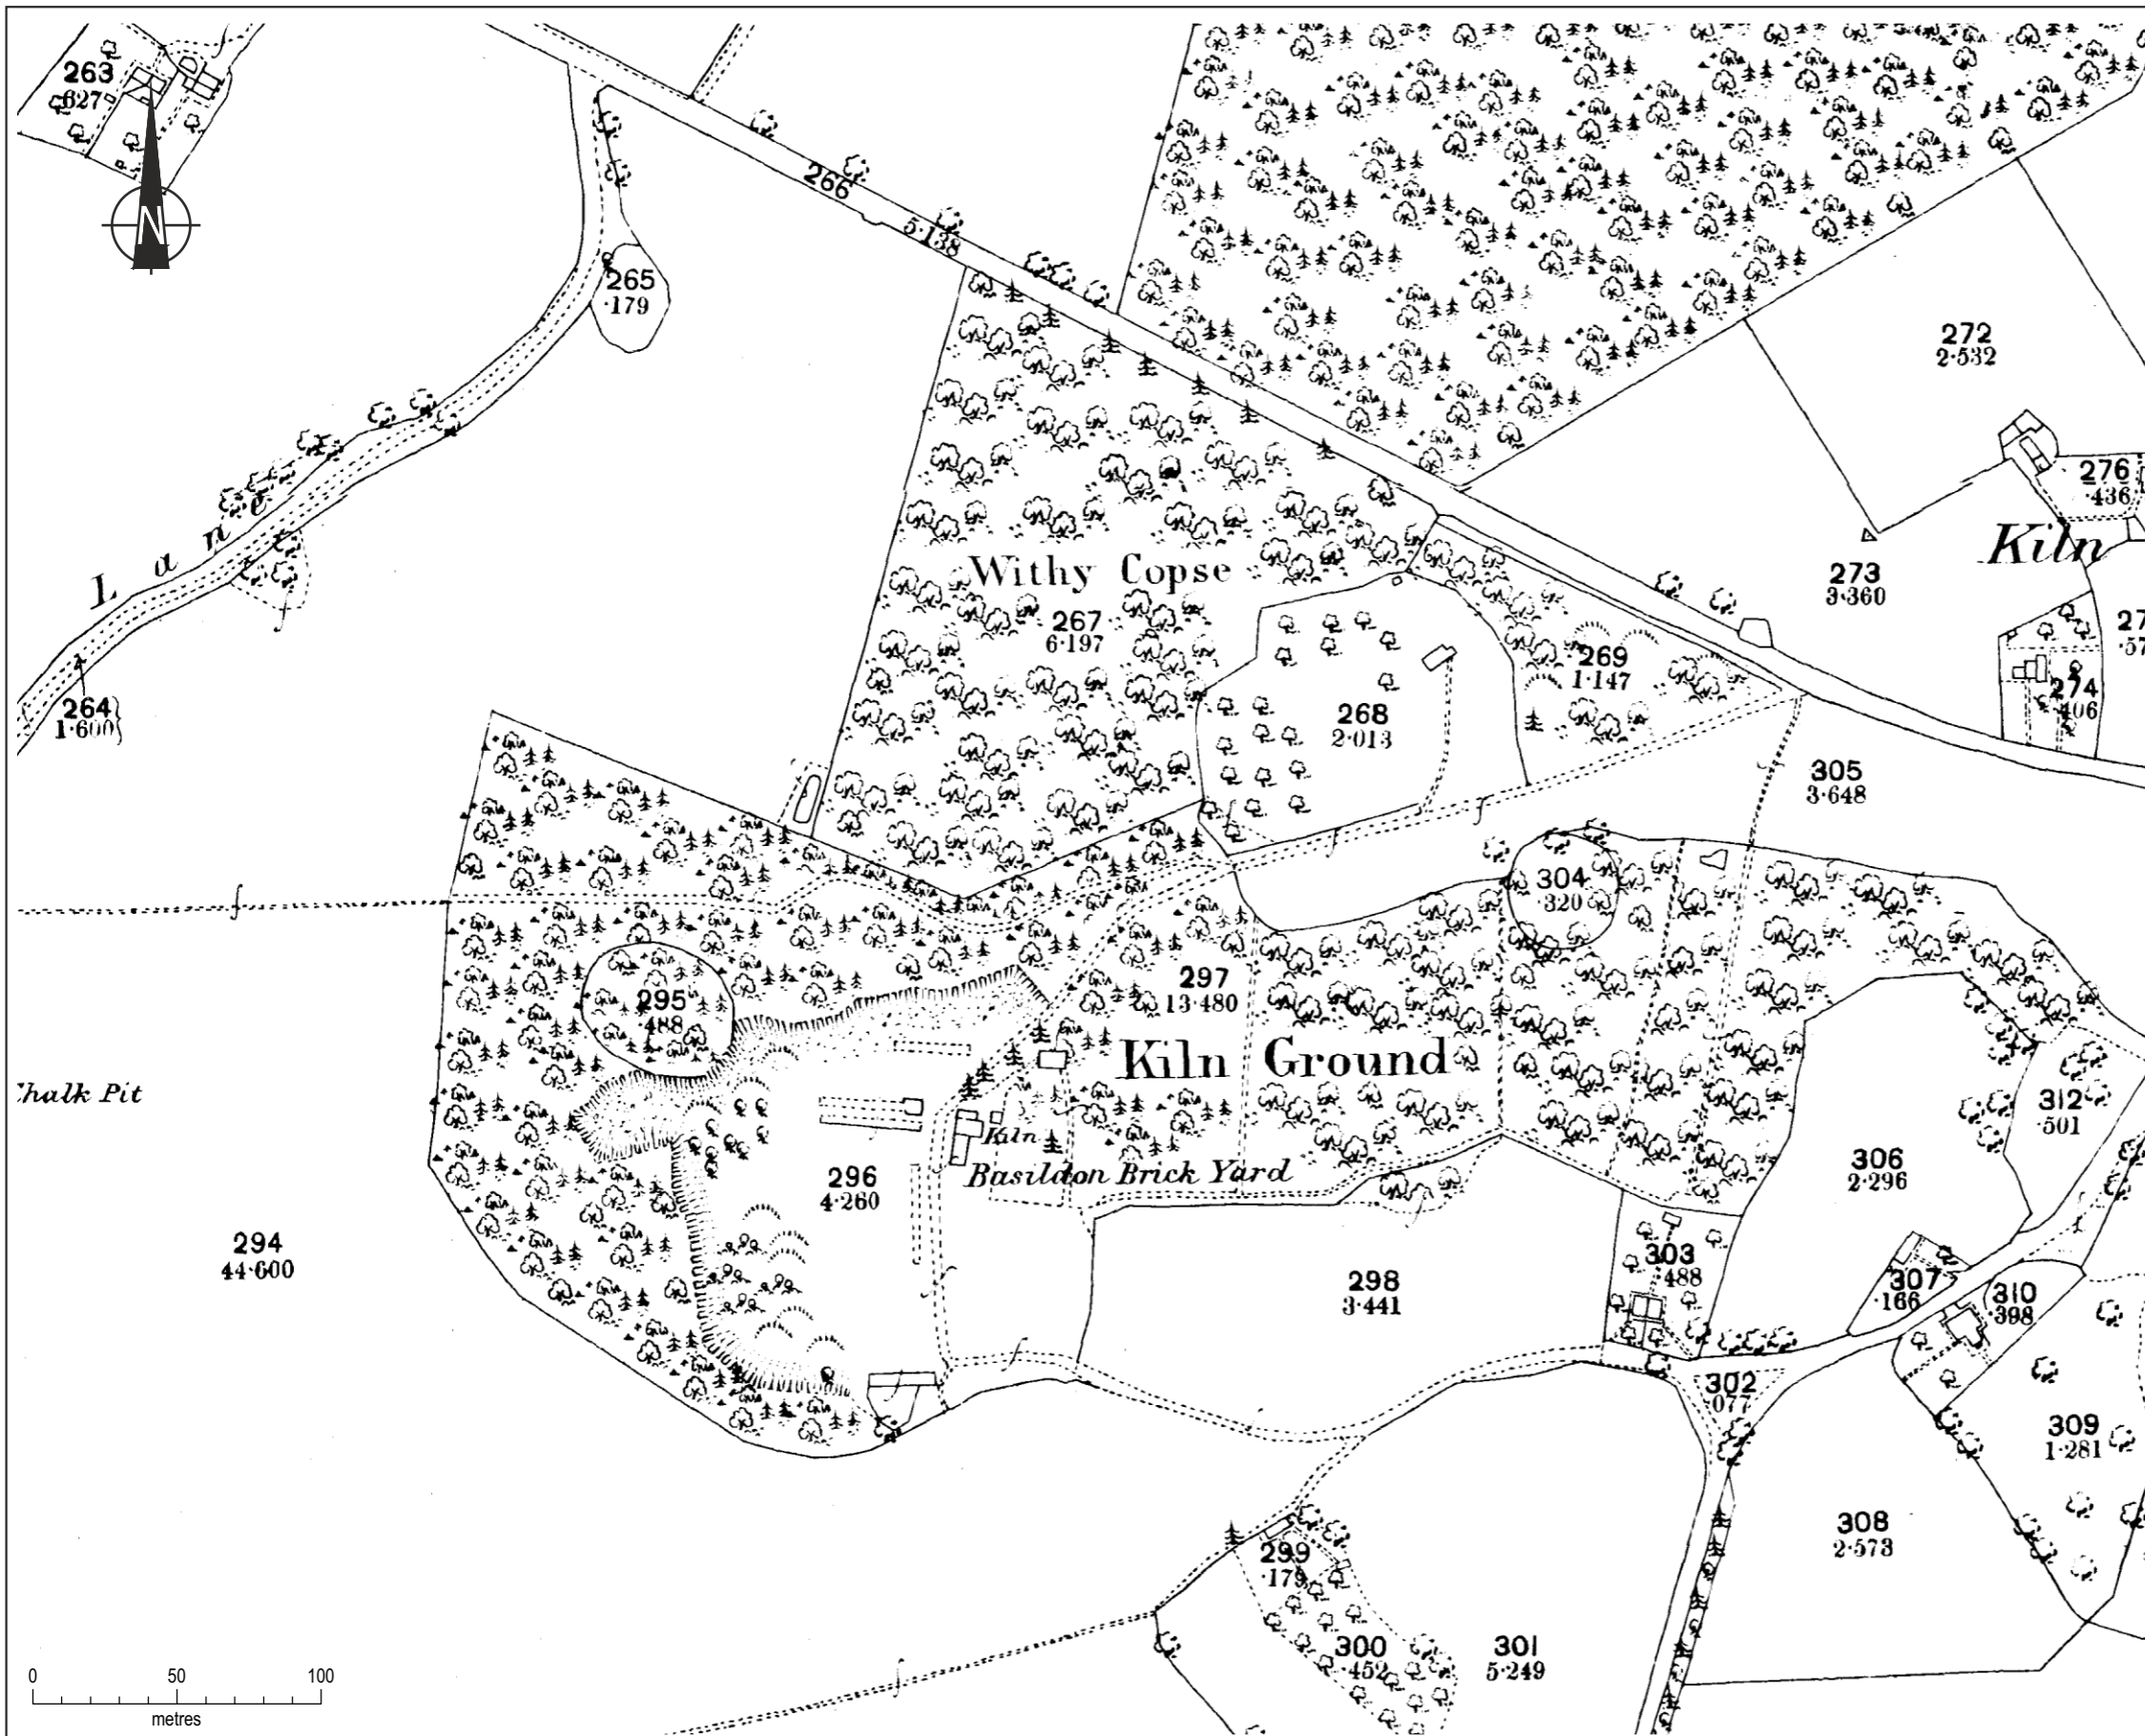
FIGURE 3

- 4.2.4 The first edition OS Map dates from 1878 (see Figure 3) and the Basildon Brick Works are again shown. An area of clay pits is clearly shown, the southern and western portion of which appear to be overgrown and no longer in use. A “kiln” is marked within the area central to the clay pits that are open and active, together with four long, narrow buildings, presumed to be drying sheds (hacks). Another rectangular building is also shown to the north east side of the kiln, close to a track. The kiln and the sheds are located further north than the positions of the same structures shown on the 1839 map which are no longer shown. The plot of land containing the brick works is marked “Kiln Ground” on the map and two circular land enclosures within the woods are shown similarly to the 1839 map.

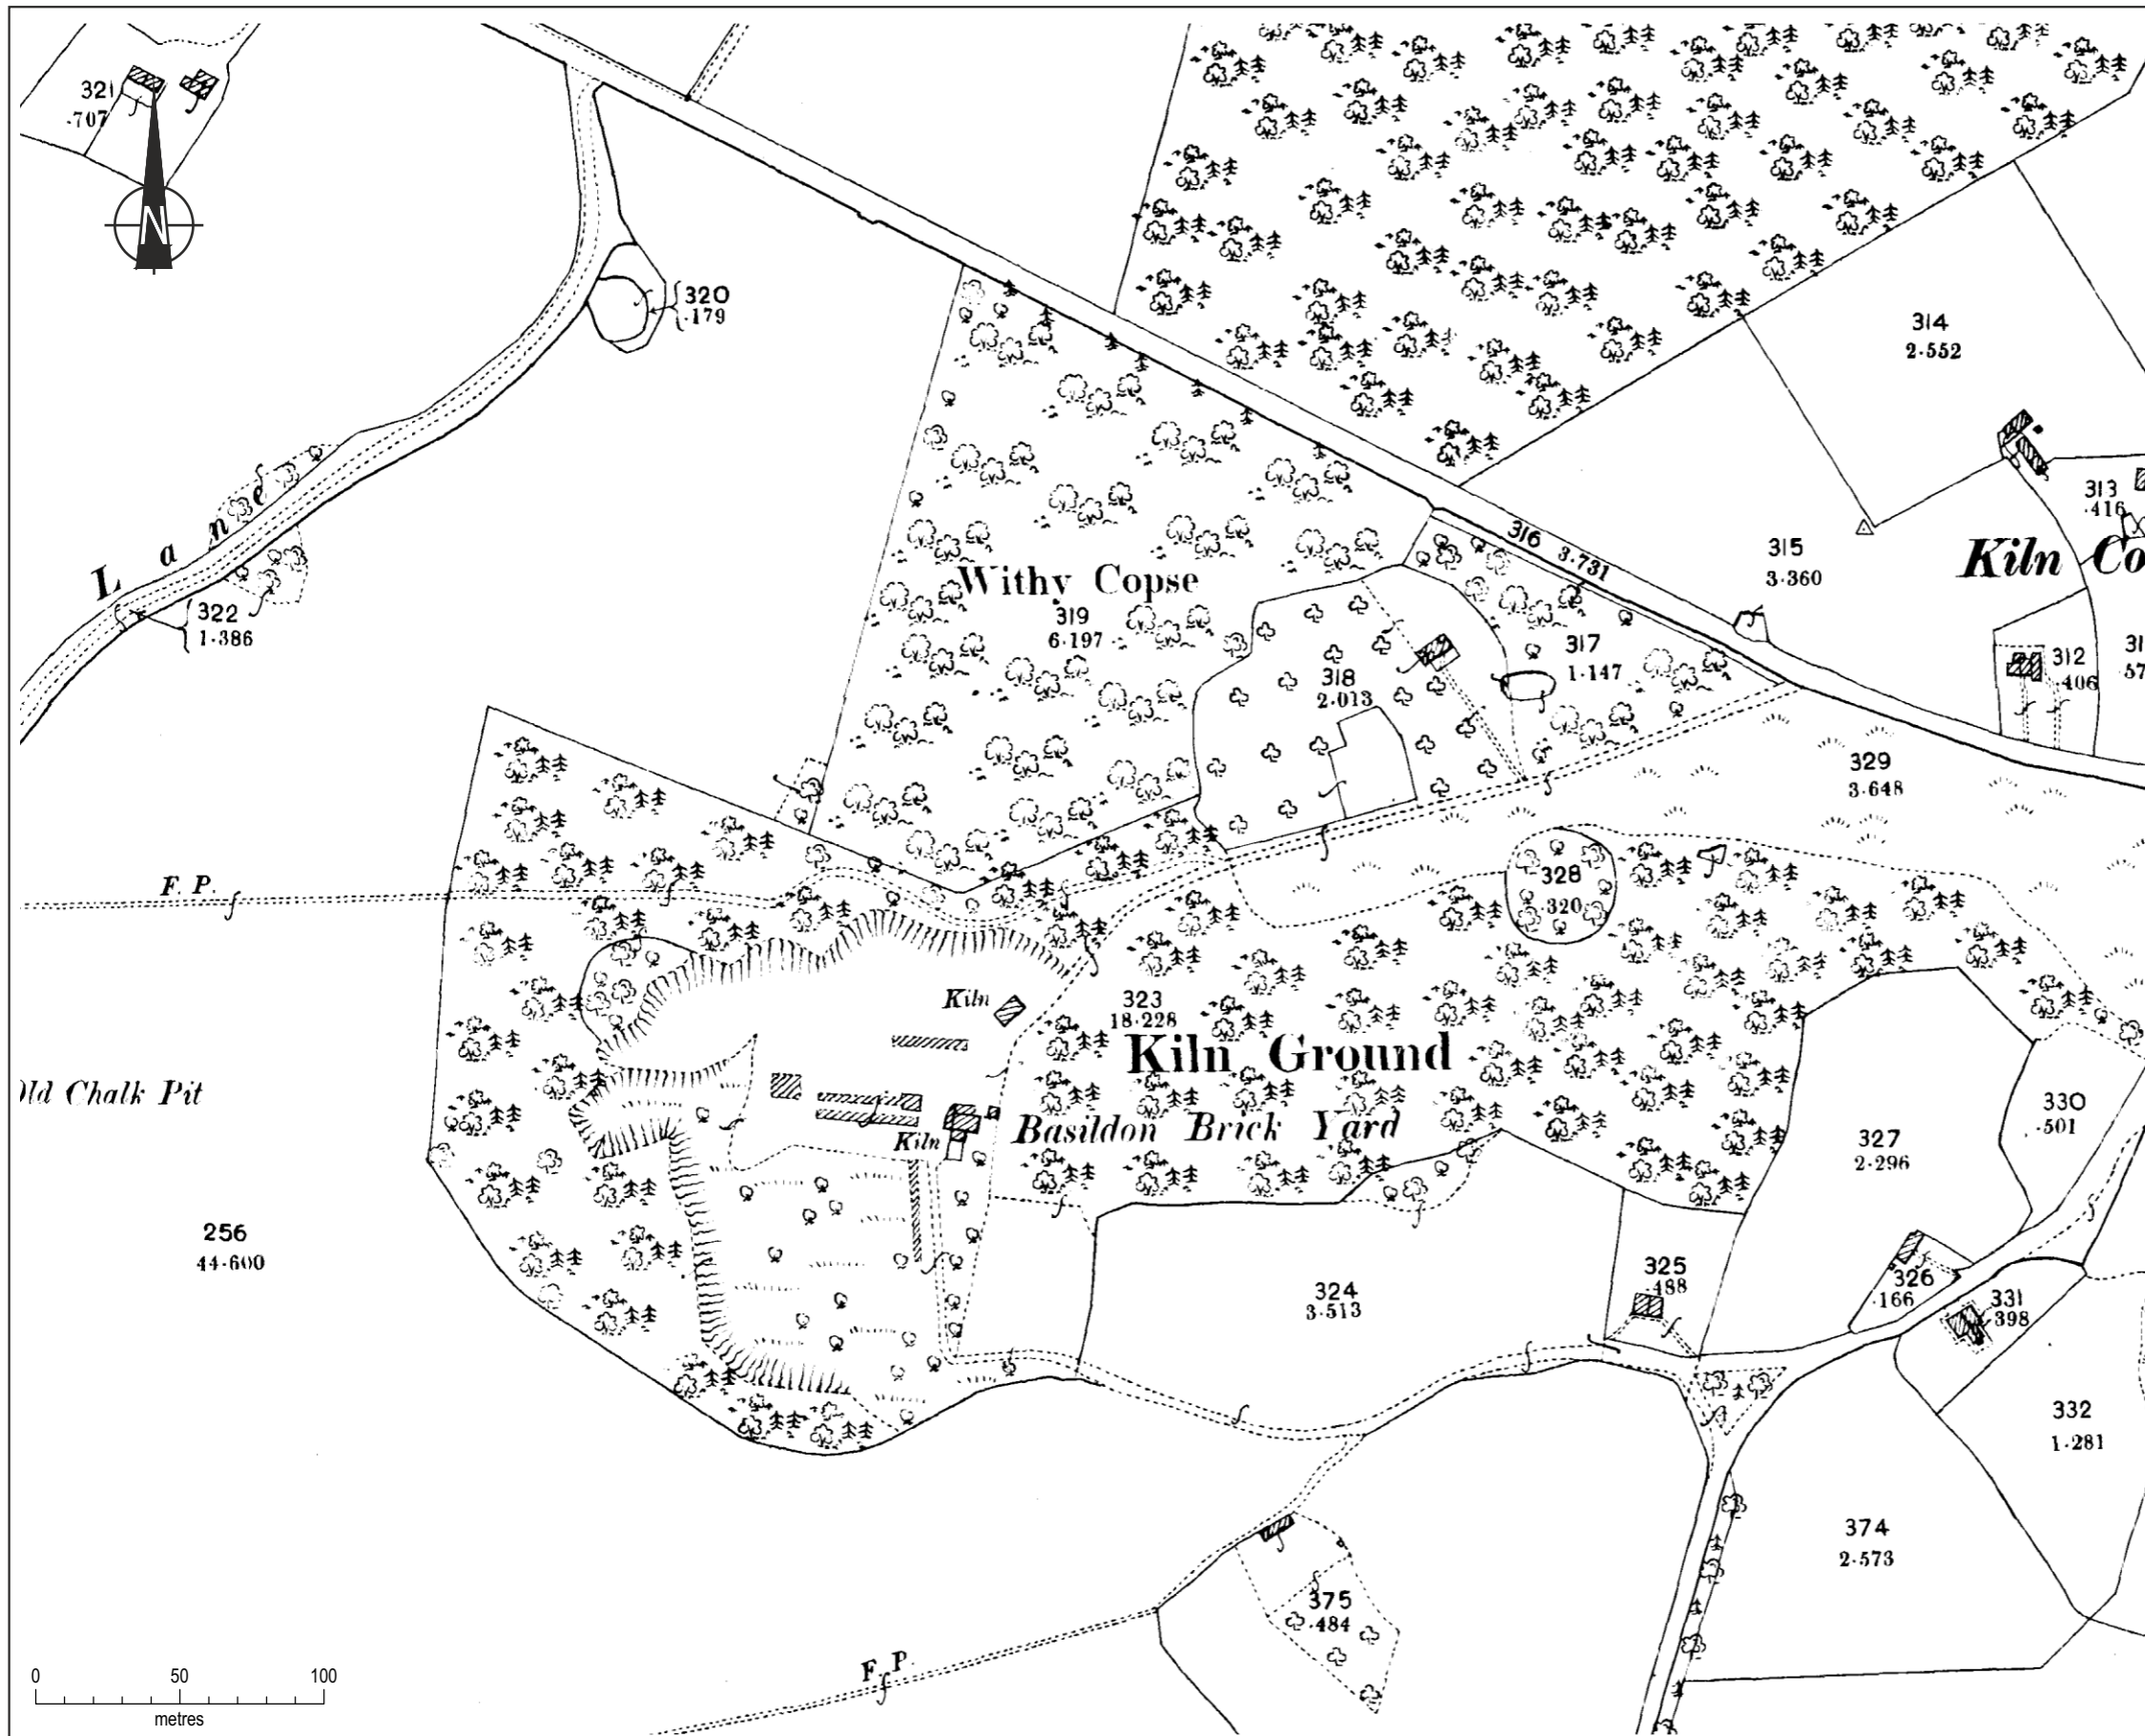
FIGURE 4

- 4.2.5 The second edition OS Map dates from 1899 (see Figure 4) which indicates that the clay pits have been extended northwards. The northern edge of the pits now runs irregularly in an east to west direction and has partially removed the western circular land enclosure feature in the woods. The old clay pits south and west of the kiln shown on the 1878 map are now shown to be overgrown and disused. The kiln dating from the 1878 map and other buildings remain largely the same as before. A second kiln is now shown to be present north of the 1878 kiln and an additional building west of the sheds as well. The rectangular building north east of the 1878 kiln is no longer shown.

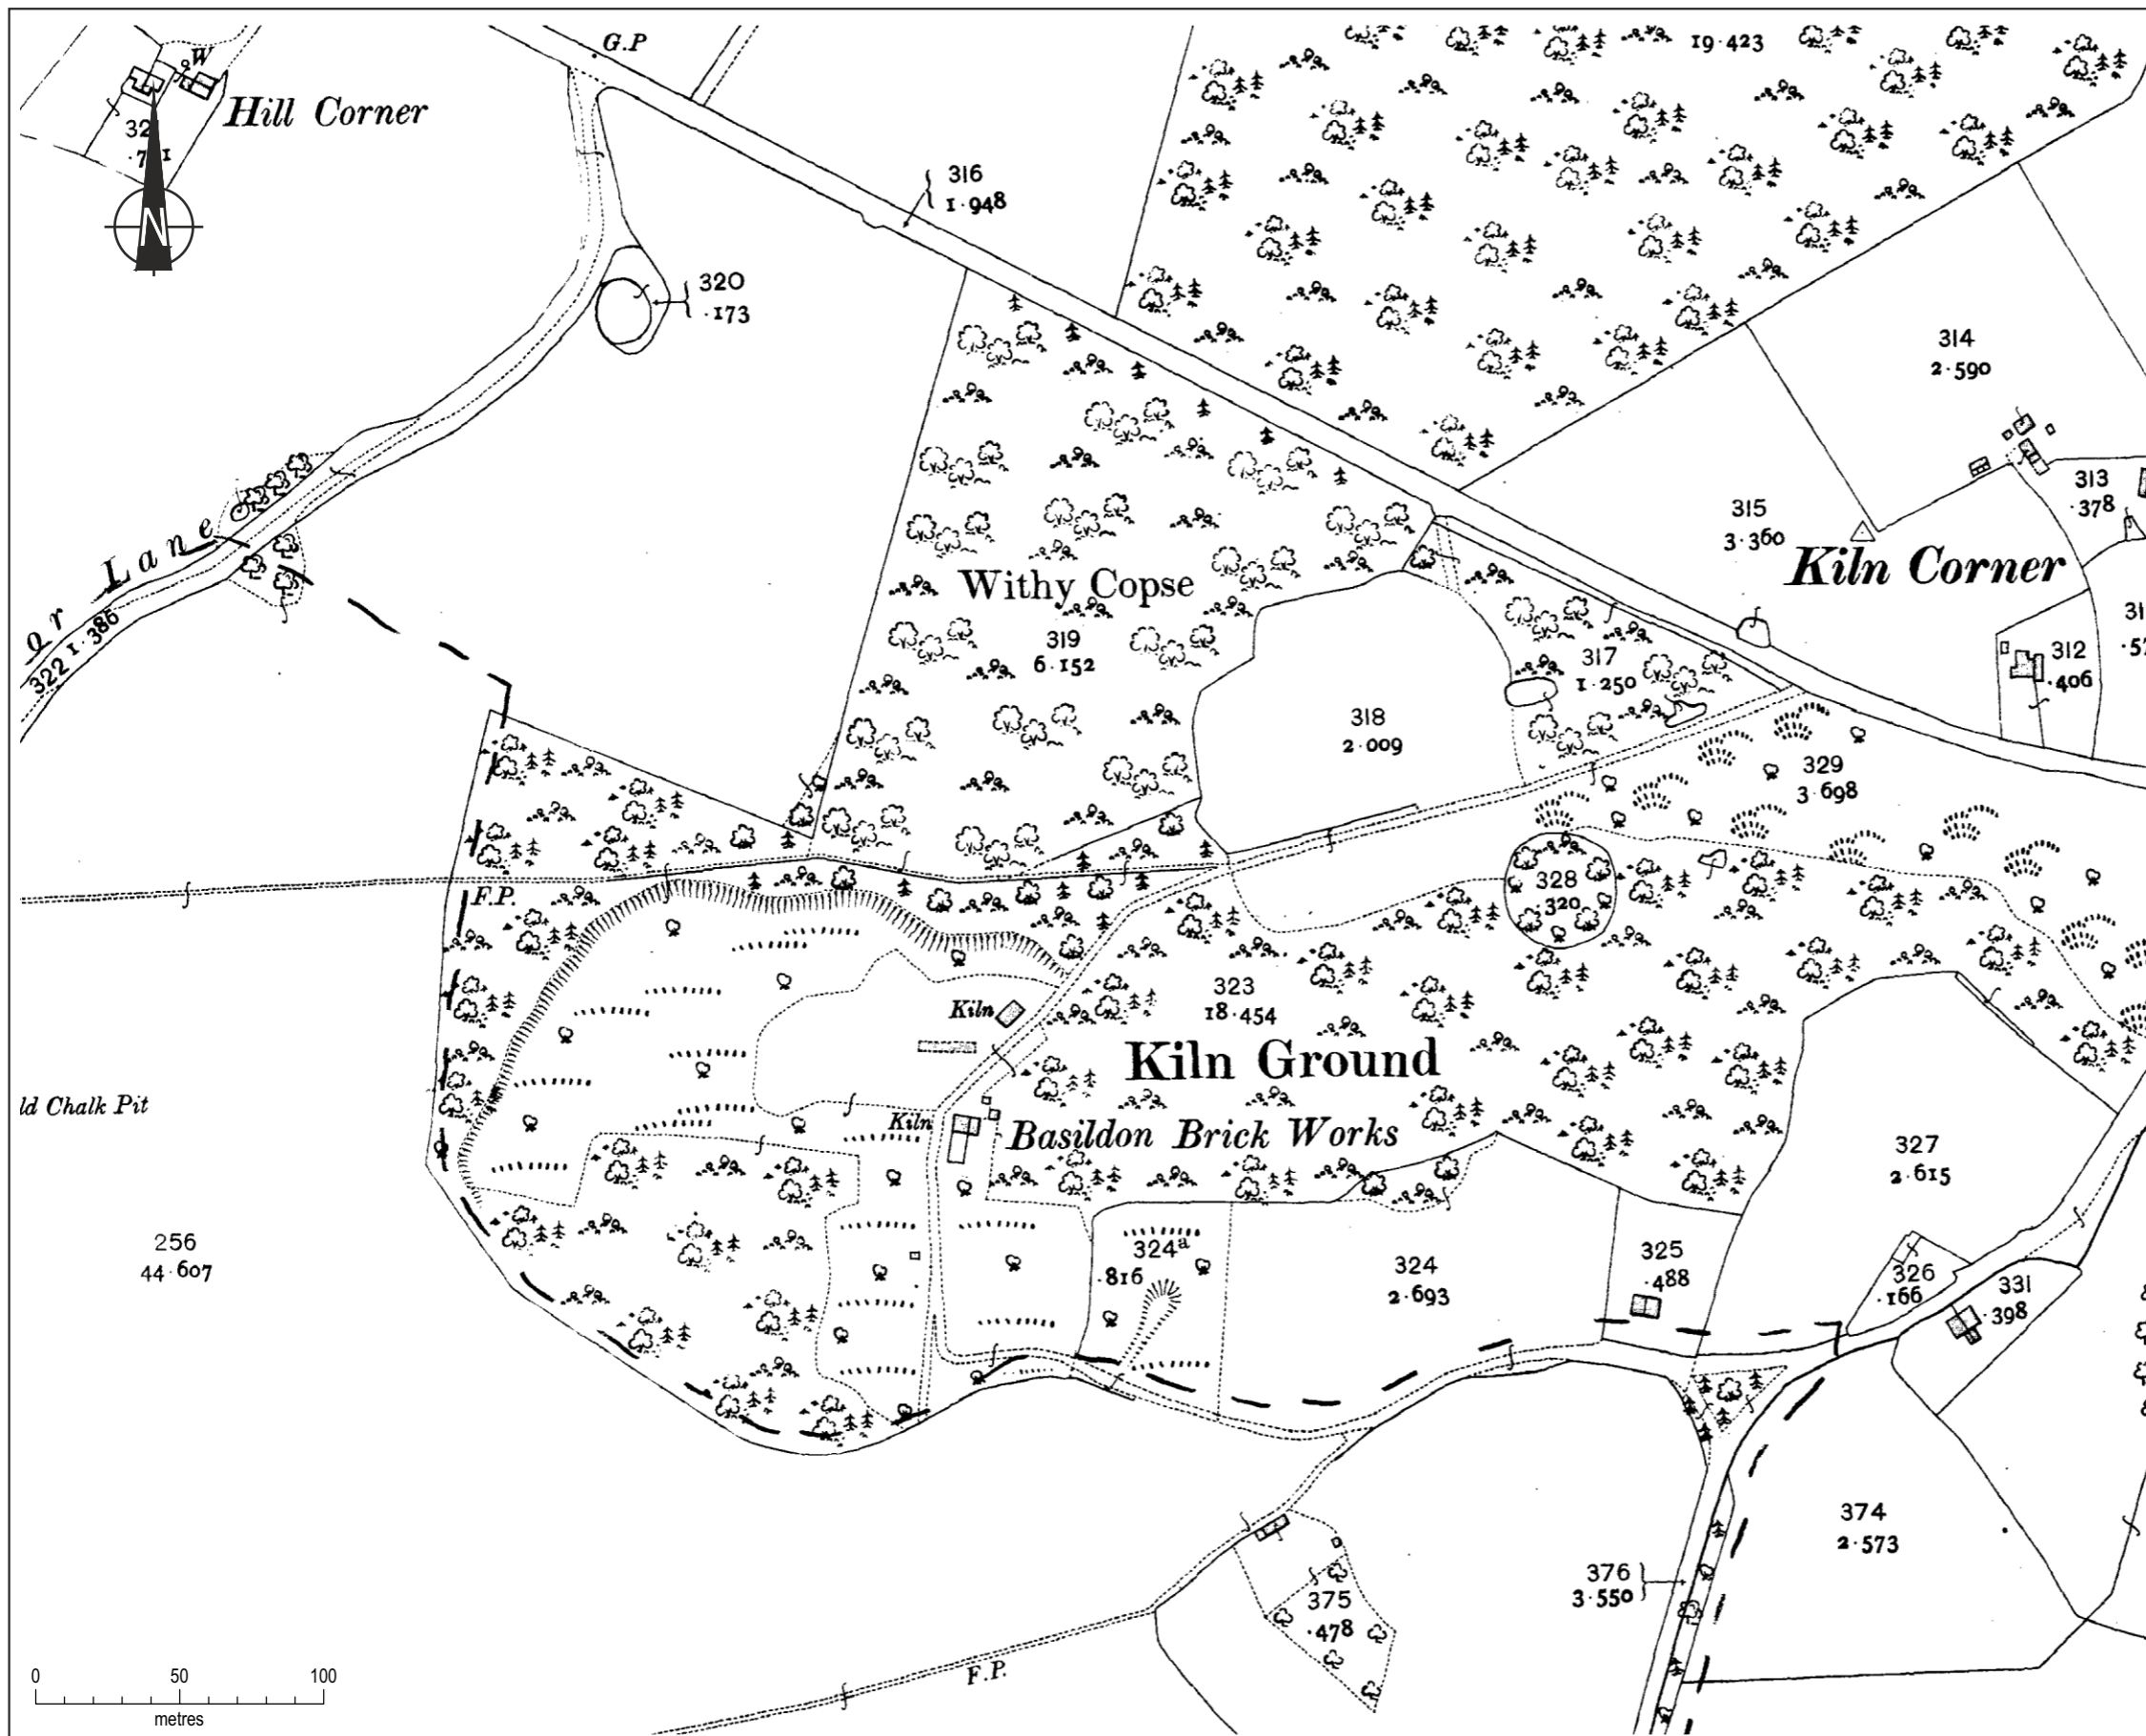
FIGURE 5

- 4.2.6 The third edition OS map dates from 1912 (see Figure 5). The map shows the same two kilns as depicted on the 1899 map, but by this time the area of clay pits has greatly expanded to both the north and west of the former areas worked, the edge of the worked out area now lying close to the footpath crossing the northern part of the Kiln Ground wooded land.

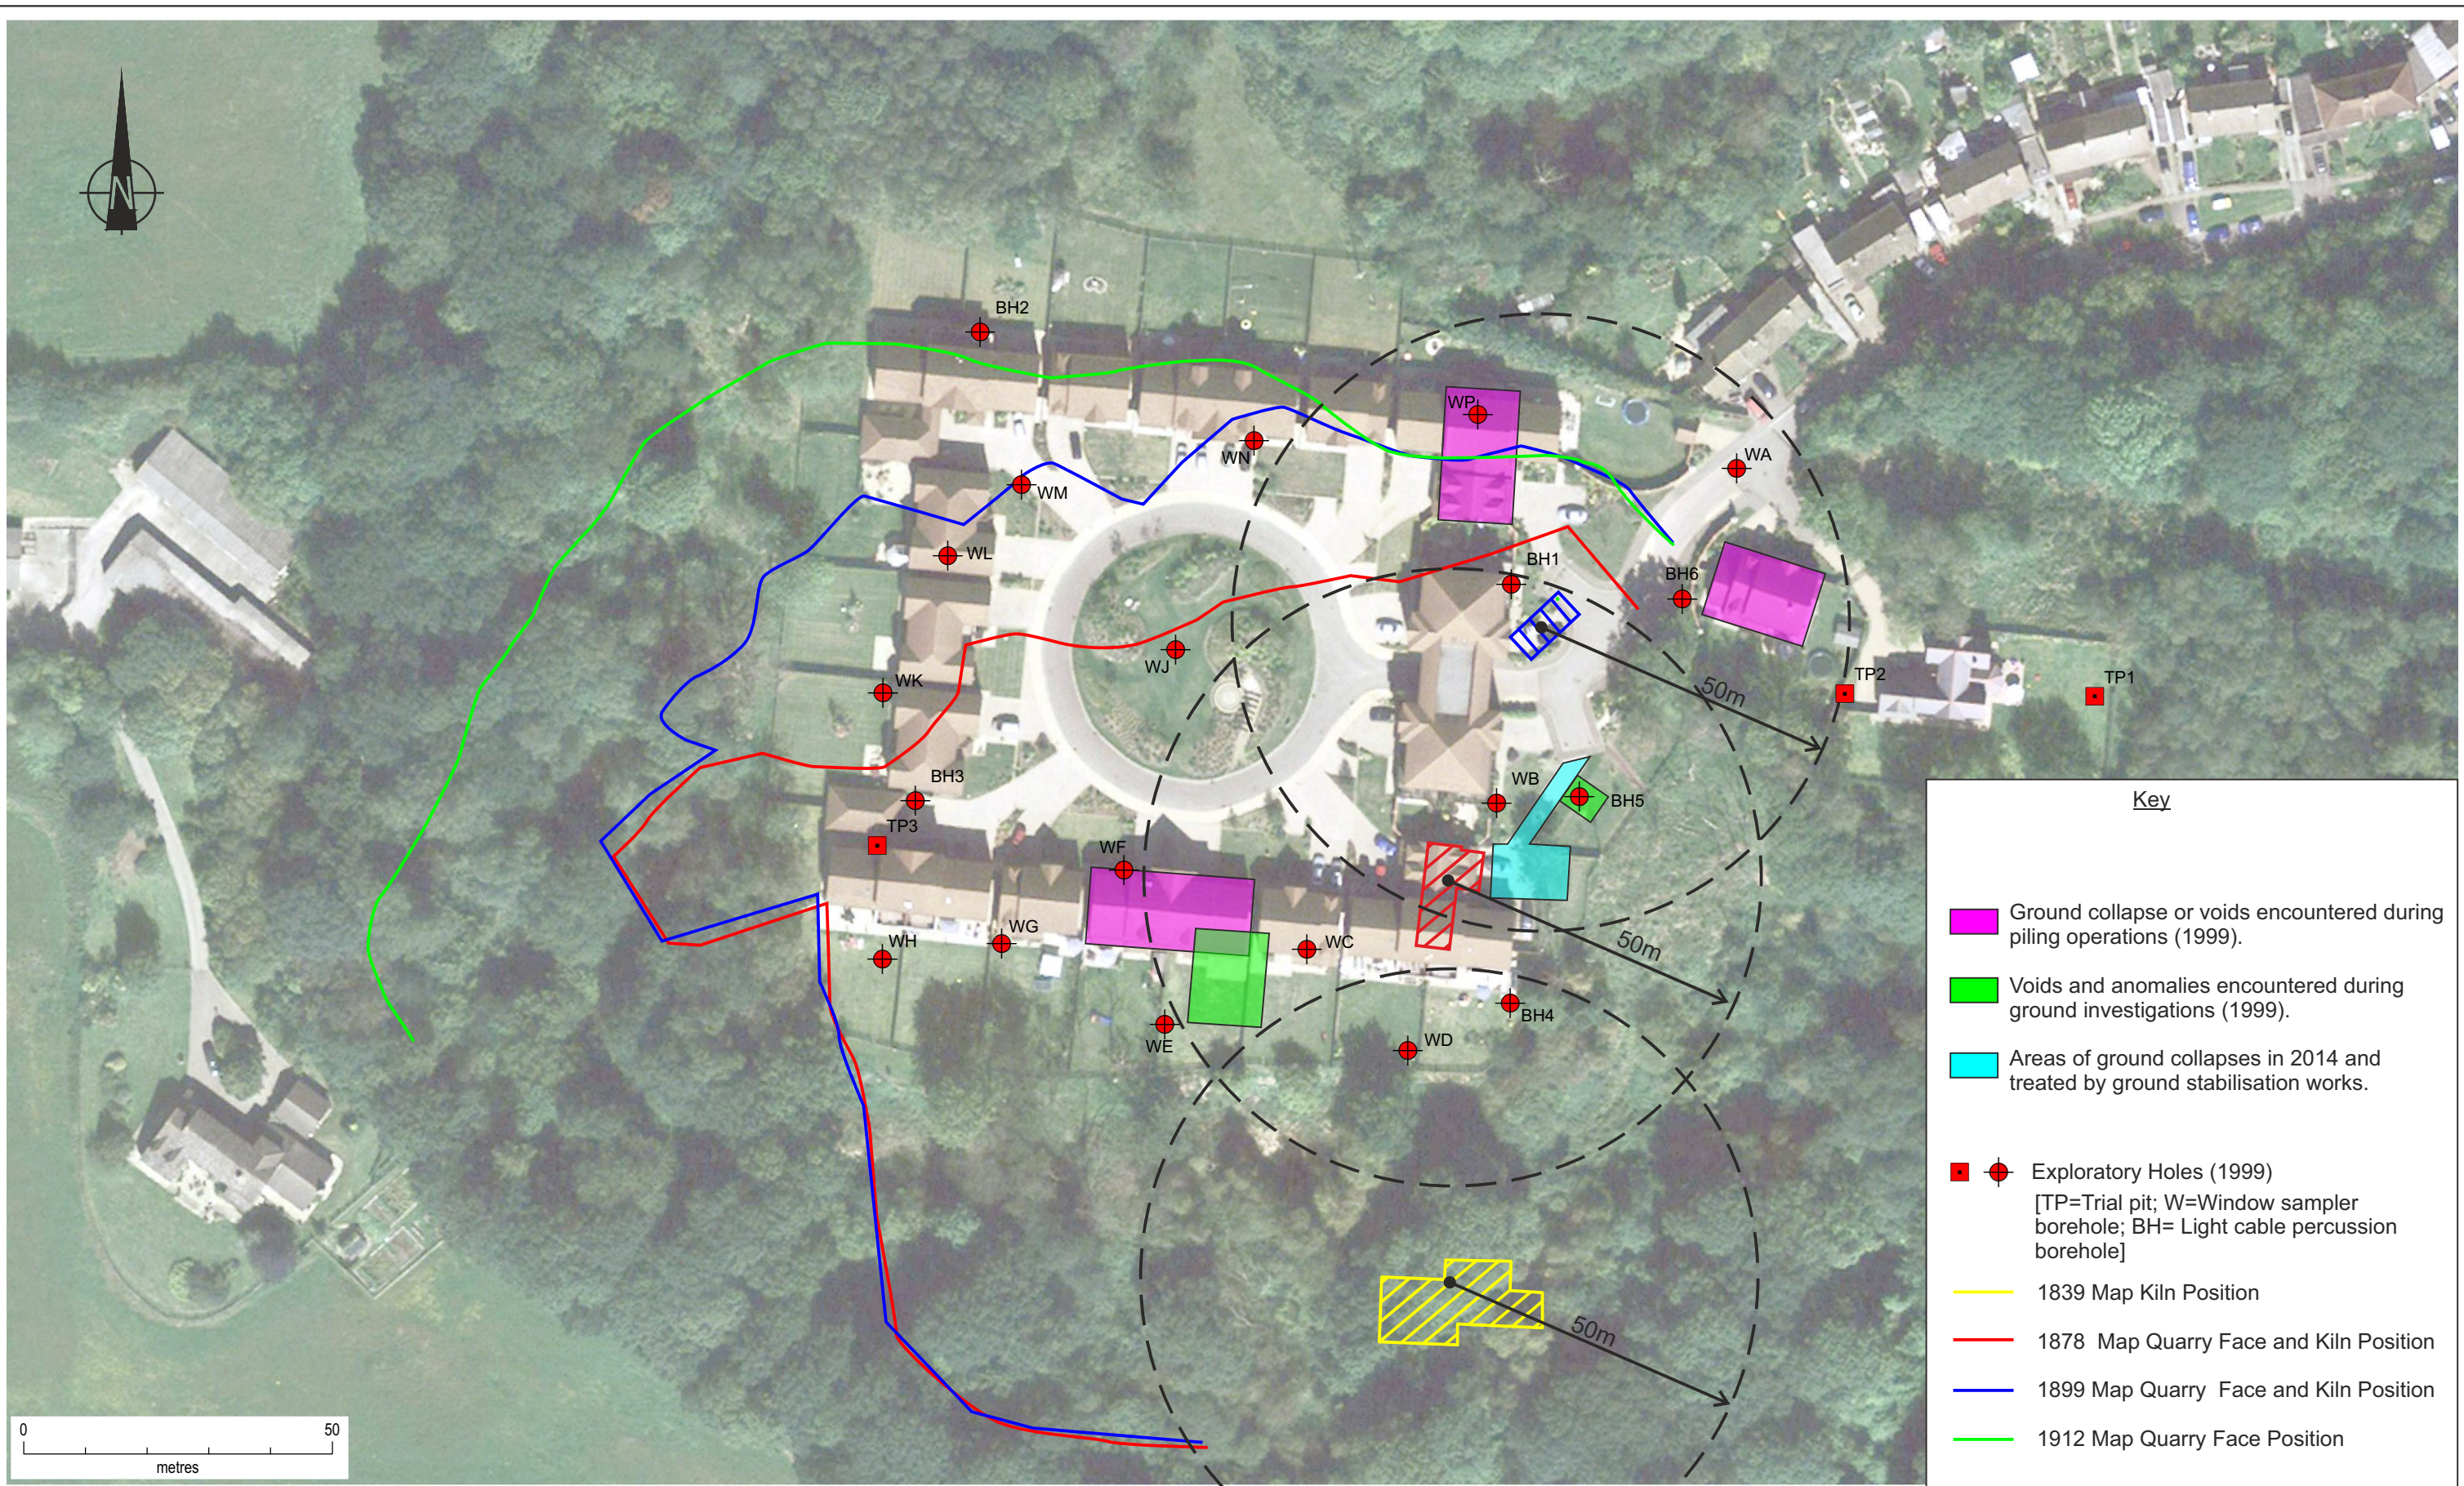
FIGURE 7

- 4.2.9 A summary of the spatial distribution of the quarrying extents and locations of kilns through time is show in Figure 7.

- 4.3.8 A summary of the spatial distribution of voids found during the investigation phase and pile installation phase is presented in Figure 7, together with the area where ground collapses and investigation/treatment of collapsing voids has taken place at Number 5 Old Stocks Court.

- 4.4.2 As Figure 7 shows, there have been 3 kiln positions noted at the Basildon Brick Works, the first from the 1839 map, the second from the 1878 map and a third one from the 1899 map edition. This situation indicates a number of scenarios: (a) a new chalk mine entry shaft was dug close to each kiln position in turn leading to the excavation of 3 small scale mines, or (b) the original mine was extended towards the new kiln position and a new shaft dug to connect with it at the new kiln position (i.e. 1 larger mine). Other variations are also possible, but in order to visualise the potential footprint that the mining options would occupy a series of 50m diameter circles have been drawn centred on each of the kilns in turn. From reviewing large

- 4.4.3 It is notable that there is a good fit between the possible mine extents shown on Figure 7 and the occurrence of voids and collapse problems recorded at the Old Stocks Court development.

- 4.4.4 In answer to Q1 (Section 1 of this report) it is considered feasible that future crown hole collapses could occur within the eastern portion of the red hatched area on Plan A as illustrated by reference to Figure 7. The properties (houses and gardens) at risk of potential ground collapse (crown hole) include Numbers 2 to 9 and 22 to 26. In addition the access road from its junction with Tenaplas Drive, through the archway and the eastern portion of the road within the open land inside the quadrangle is also at risk of crown hole collapse, as would be any of the adjacent open land owned by the management company.

- 4.4.5 In answer to Q2 (Section 1 of this report) it is considered feasible that future crown hole collapse could occur to the south and east of the Old Stocks Court development overlapping the area which is hatched in black on Plan B as illustrated by reference to Figure 7.

- 4.4.6 In answer to Q3 (Section 1 of this report) it is considered feasible that future crown hole collapse could occur possibly at the junction of the Old Stocks Court access road with the western end of Tenaplas Drive which is shaded blue on Plan A as illustrated by reference to Figure 7.

- 4.7.4 There is a range of evidence suggesting that extensive mine workings are present below the development as indicated by the areas shown on Figure 7. There are a variety of ways to investigate and map the mine workings and in order to fully risk assess the situation it would be best if further investigation was carried out.

- 4.7.5 The most positive proof of the presence of mine workings would be obtained by carrying out rotary drilling on a grid pattern across the area, but this would be very expensive for the size of area indicated in Figure 7. Dynamic probing on a grid pattern offers another cheaper technique to detect and locate mine workings but as was experienced at Number 5 there are hard obstructions in the made ground below the development platform that prevent the probes achieving the ground penetration wanted. Therefore the benefits of dynamic probing are limited.

- 4.7.6 Another option would be to carry out a geophysical survey (probably a combination of microgravity and resistivity surveys) to be able to penetrate sufficiently into the ground and cover the entire area at more reasonable cost and with least inconvenience to residents. Such a survey approach would not produce a detailed mine plan, but should be capable of determining broad areas where the ground is disturbed by mining and where voids are in the process of upward migration – this approach has been used before on other mining projects. Once the area of disturbance due to mining is better defined then it would be necessary to carry out intrusive investigations to assess the risks in more detail.
