Project name :
140618_00

Date :
18/06/2014

Site: **Old Stocks Court**
 Contact Name:
 Department:
 Road:
 Town:
 County:
 Telephone:
 Fax:
 Mobile:
 E-mail:

Contractor **OPC Drain Services**
 Contact Name:
 Department:
 Road: **Field Barn Farm, Ardington**
 Town: **Wantage**
 County: **OX12 8PW**
 Telephone: **01235 835999**
 Fax:
 Mobile:
 E-mail: **richard@opc.me.uk**

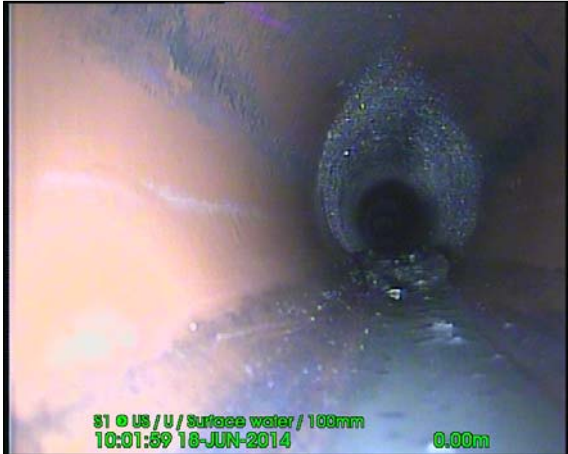
Photo: 140618_1001C-Survey.jpg
0m, Start node type, manhole reference number: S1

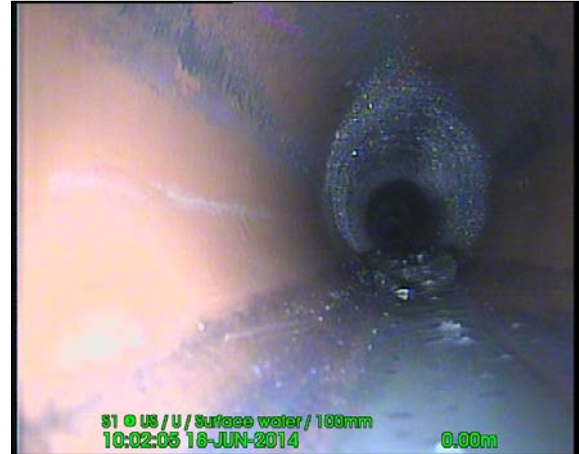
Photo: 140618_1002A-Survey.jpg
0m, Water level 5 % of the vertical dimension

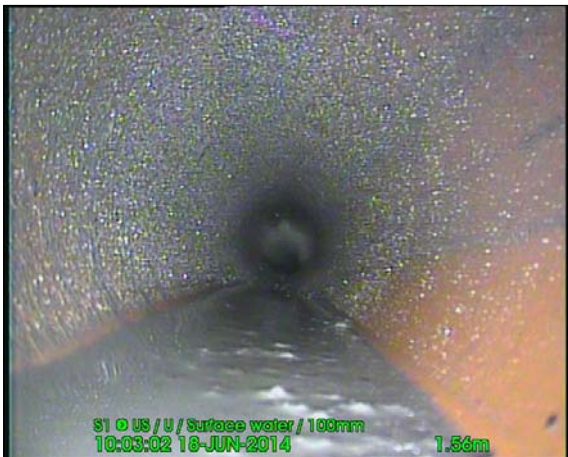
On arrival to site we attempted to survey from chambers down to soakaway but due to high water levels we were unable to get any pictures however we have traced the drain with our sonde and both pipe stop within a metre of each other which we marked the position.

Photo: 140618_1003A-Survey.jpg
1.56m, Settled deposits, fine 15 % cross-sectional area loss
S1 UNABLE TO JET SOAKAWAY FULL

I would suggest excavating on the position of the soakaway to evaluate the soakaway and to then decide on further actions.

When the soakaway is sorted the rest of the drains and chambers require a good clean and chambers emptied of all silt.

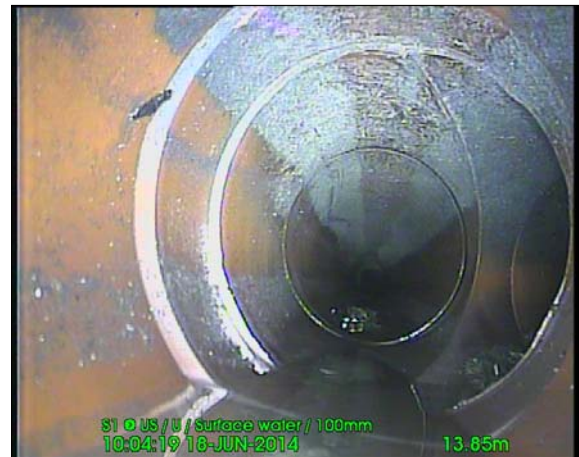
Photo: 140618_1004A-Survey.jpg
13.85m, Junction from 3 O'Clock diameter: 100 mm

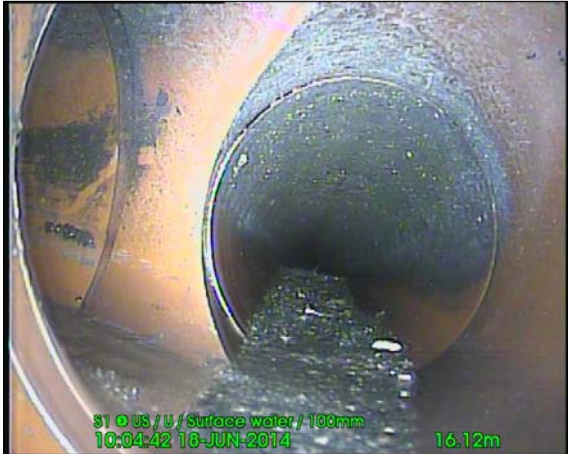
Photo: 140618_1004B-Survey.jpg
16.12m, Junction from 9 O'Clock diameter: 100 mm

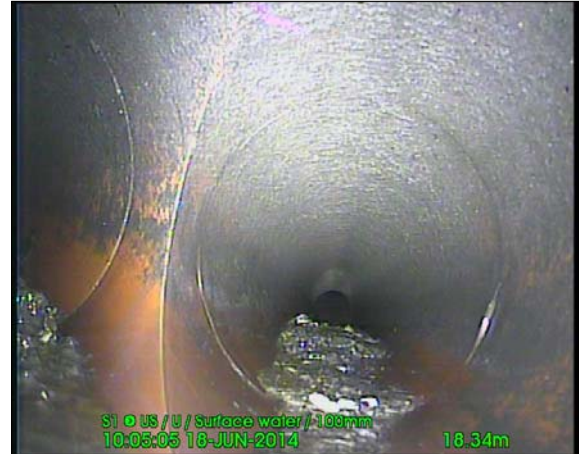
Photo: 140618_1005A-Survey.jpg
18.34m, Junction from 9 O'Clock diameter: 100 mm

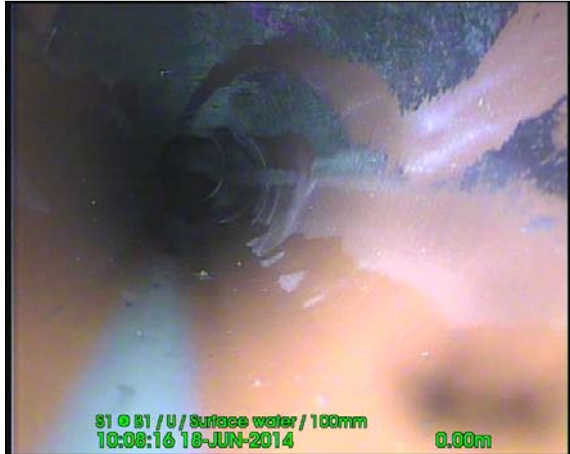
Photo: 140618_1008C-Survey.jpg
0m, Start node type, manhole reference number: S1

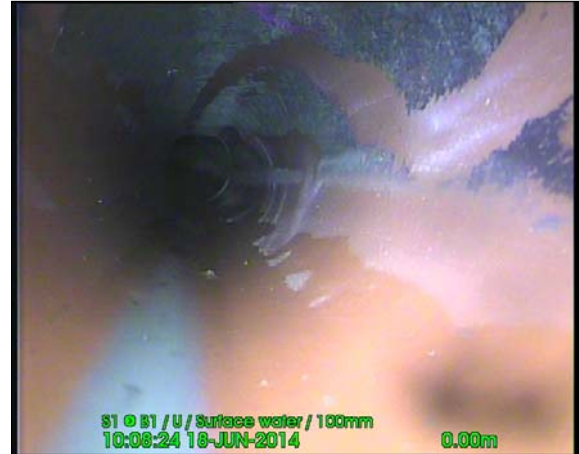
Photo: 140618_1008D-Survey.jpg
0m, Water level 5 % of the vertical dimension

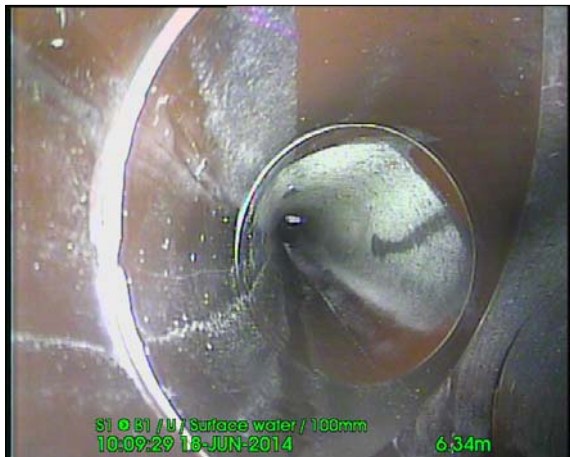
Photo: 140618_1009A-Survey.jpg
6.34m, Junction from 3 O'Clock diameter: 100 mm

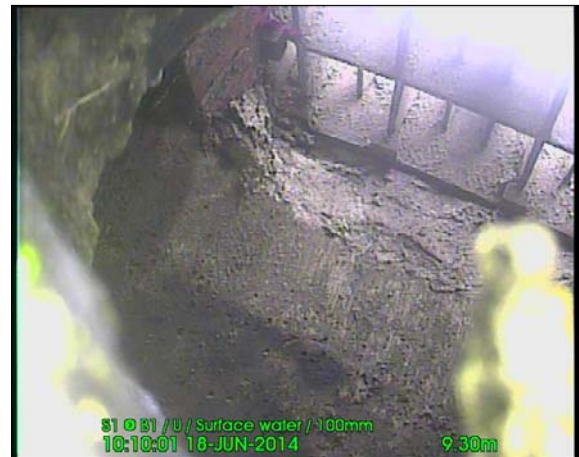
Photo: 140618_1010A-Survey.jpg
9.3m, Finish node type, manhole reference number: B1 ROAD GULLY

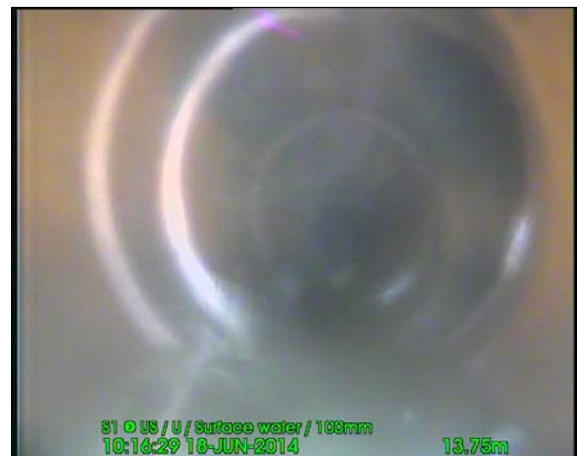
Photo: 140618_1016A-Survey.jpg
13.75m, Junction from 3 O'Clock diameter: 100 mm

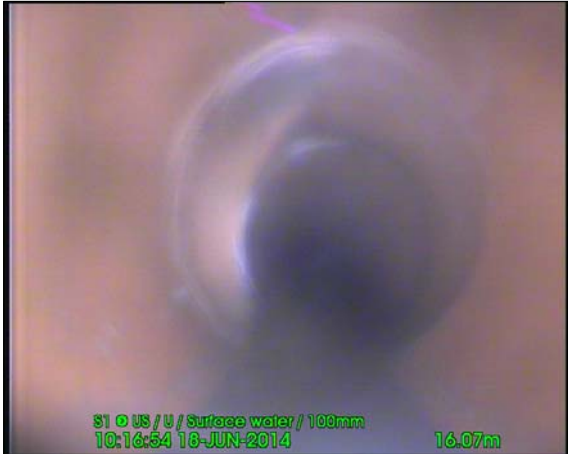
Photo: 140618_1016B-Survey.jpg
16.07m, Junction from 9 O'Clock diameter: 100 mm
