Geotechnical Review

**Consideration of Ground Conditions and Subsidence Hazard
to Old Stocks Court, Upper Basildon, Berkshire**

Doc Ref: GRR001/Rev02

Date: September 2015

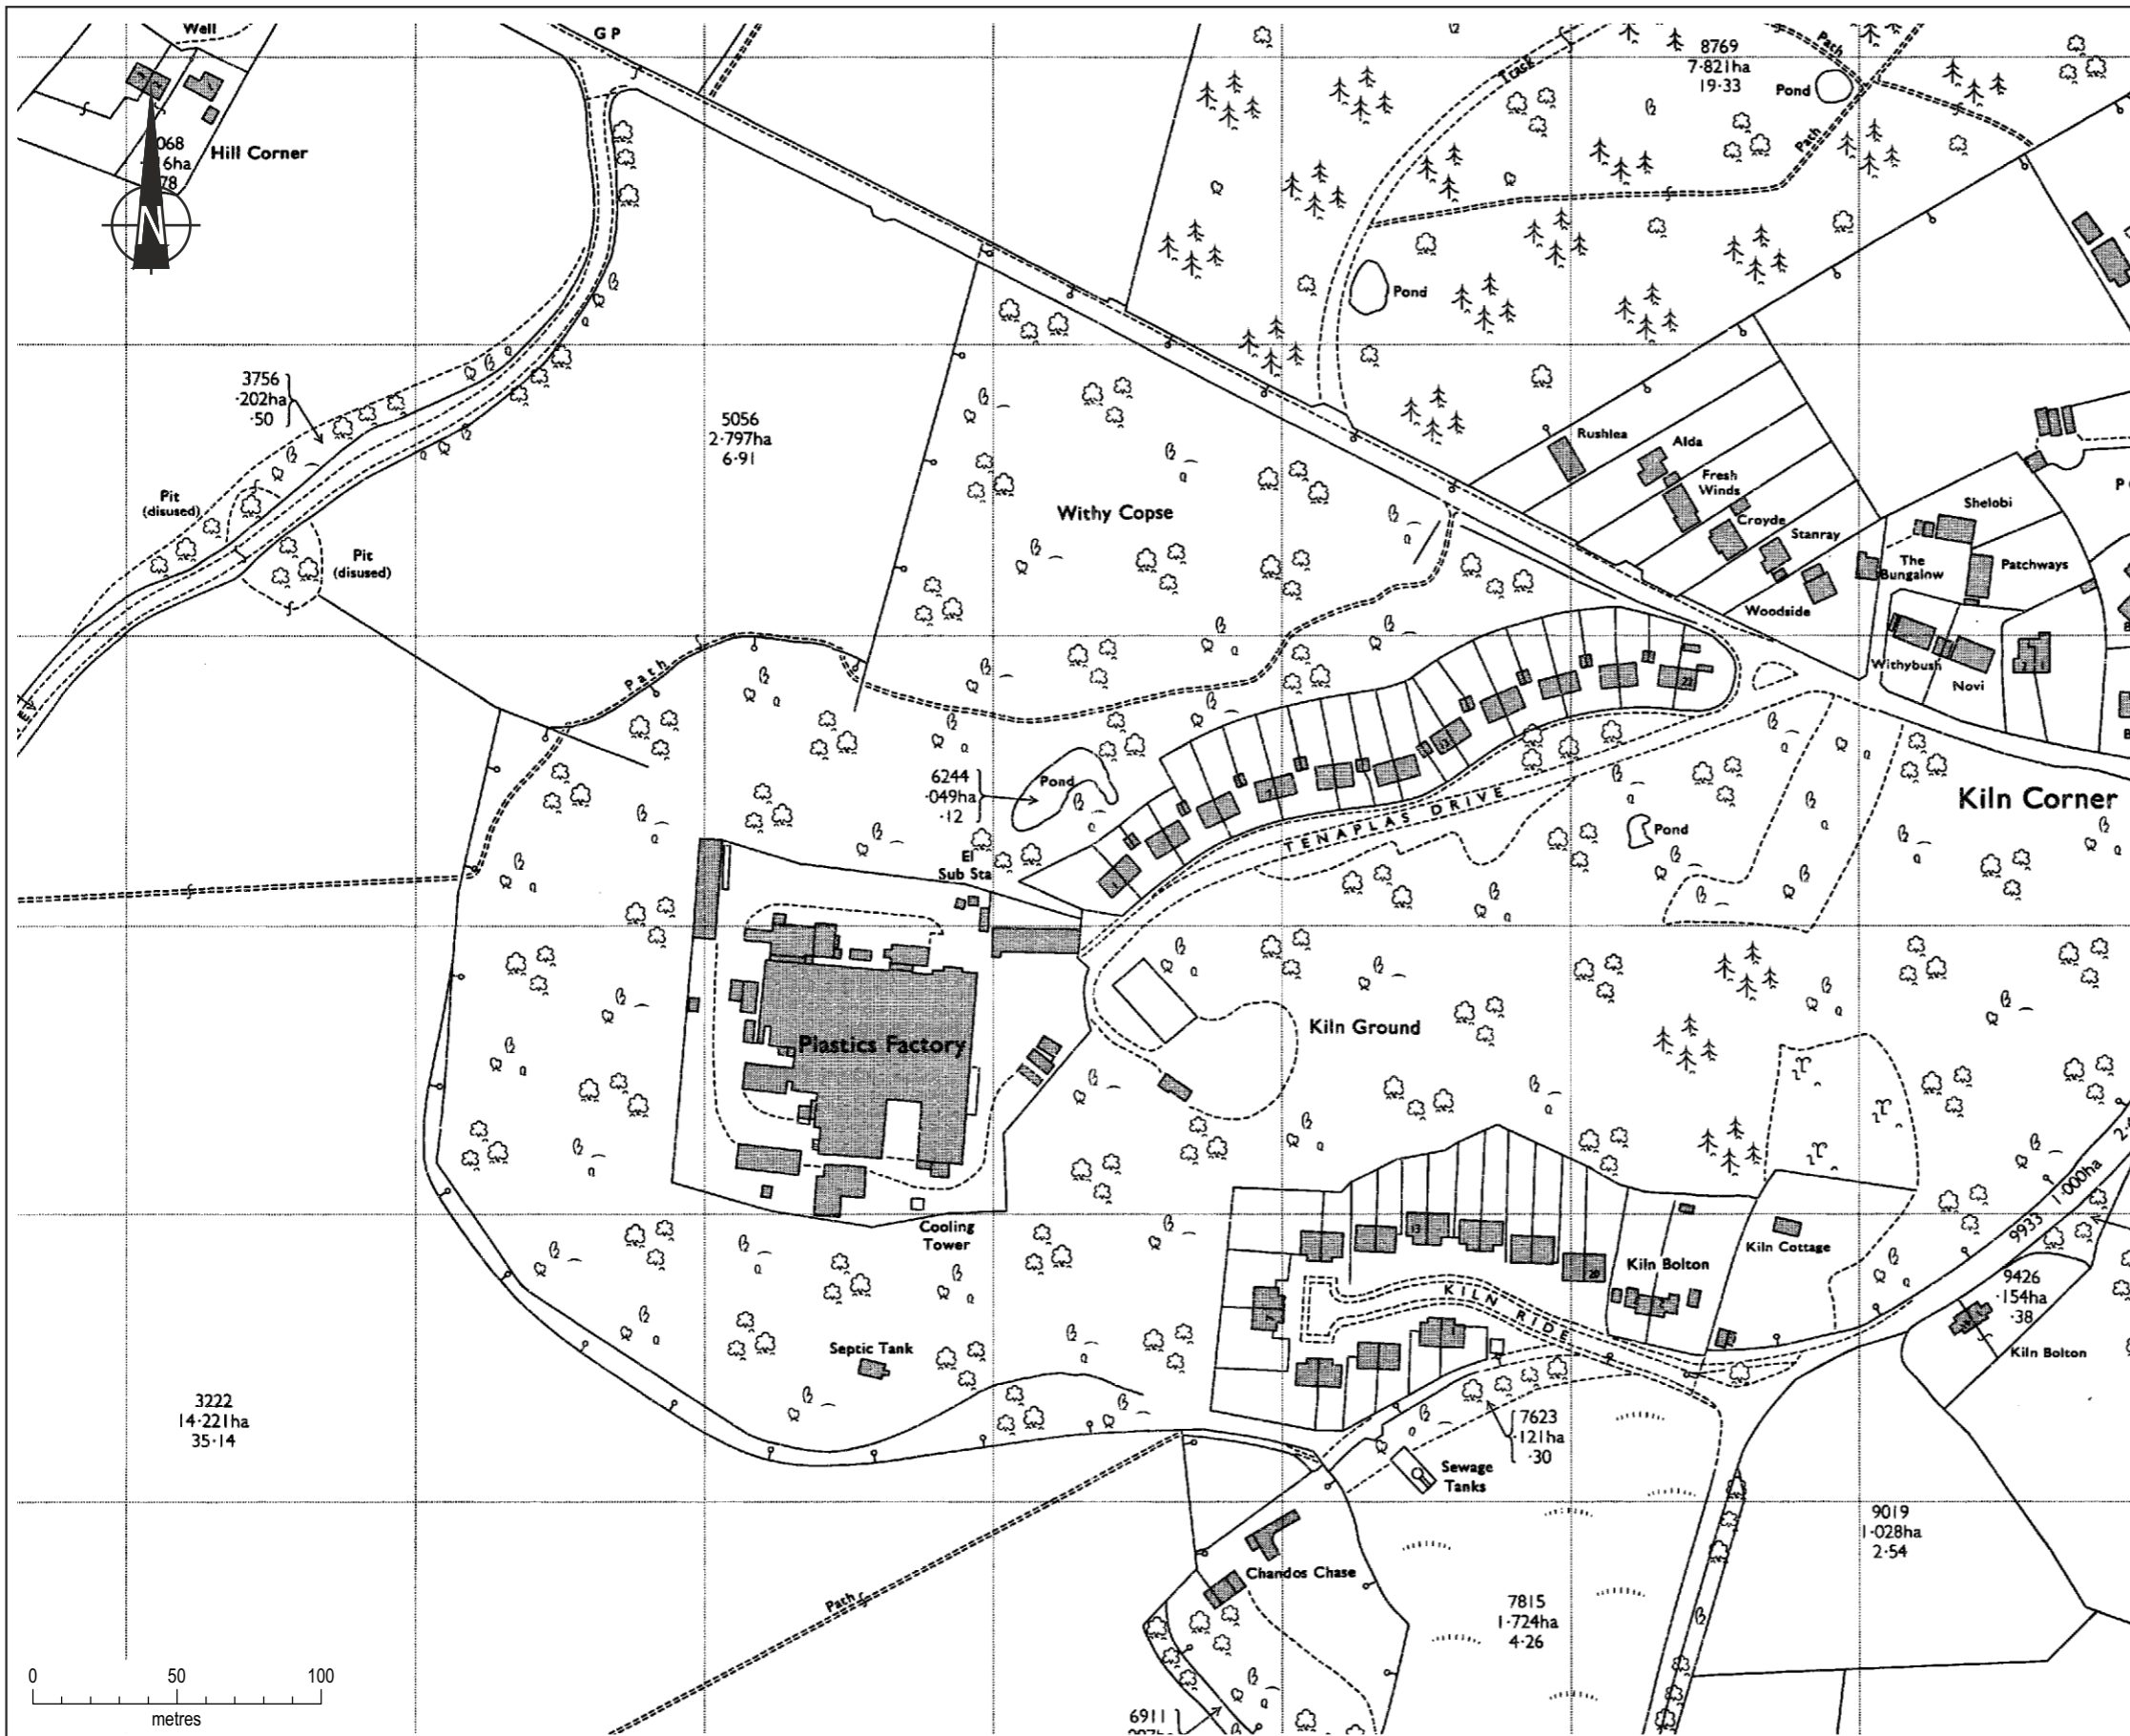
FIGURE 5

- 4.2.6 The third edition OS map dates from 1912 (see Figure 5). The map shows the same two kilns as depicted on the 1899 map, but by this time the area of clay pits has greatly expanded to both the north and west of the former areas worked, the edge of the worked out area now lying close to the footpath crossing the northern part of the Kiln Ground wooded land.
